# Arboricultural Report

## Tree Condition Assessment

Kington Lane Cemetery

Ref: WTC\_1041.01

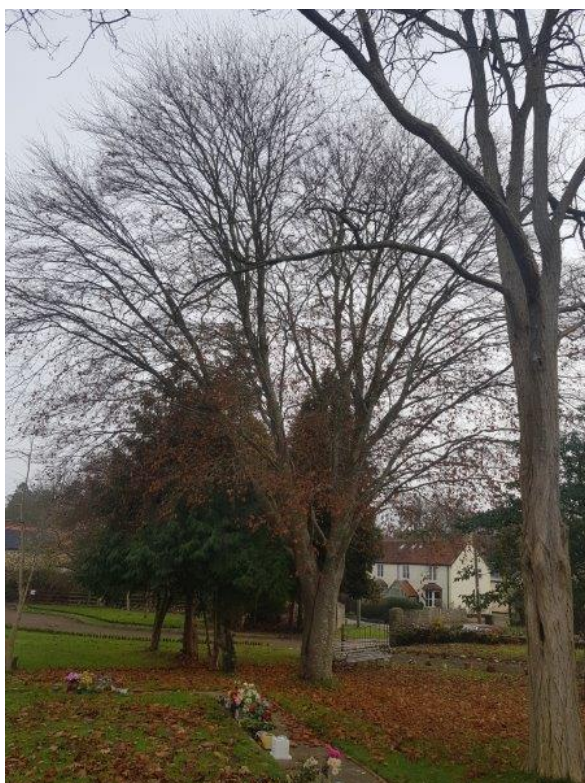
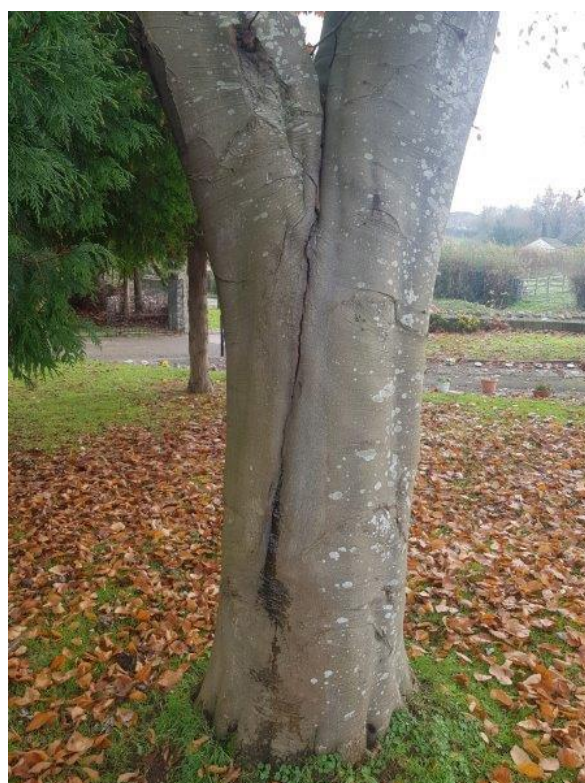
- 9.1 T3 – Purple beech** – A vertical crack has been slowly progressing from the main union down the trunk for the last 3 years. In order to arrest the progress of the crack it is recommended that a static metal rod brace is fitted and the canopy is reduced to lessen stress and strain on the brace.

Plate 1: T3 – Purple beech with progressive vertical crack below main union. Static rod bracing recommended.
