# Arboricultural Report

## Tree Condition Assessment

Thicket Walk Open Space

**19th December 2022**

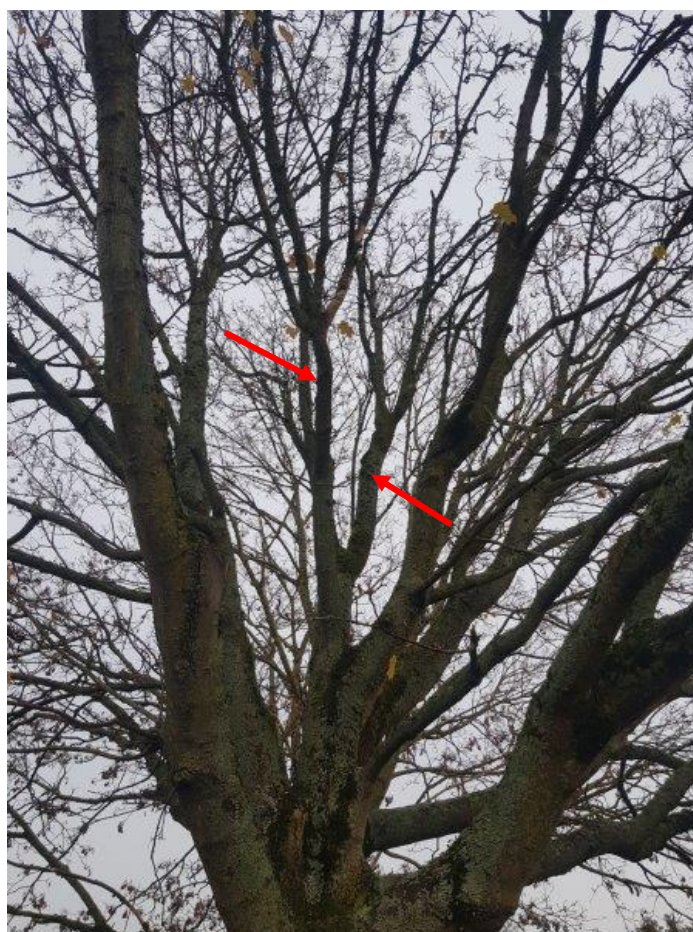
- 8.1 T10 – Norway maple** – This tree is showing early signs of Verticillium wilt. This fungal disease is exacerbated during periods of hot, dry weather such as that experienced in the summer of 2022.

Whilst no cure exists it can be managed by removing the dead branches back to live wood.
