# Arboricultural Report

## Tree Condition Assessment

Thicket Walk Open Space

**19th December 2022**

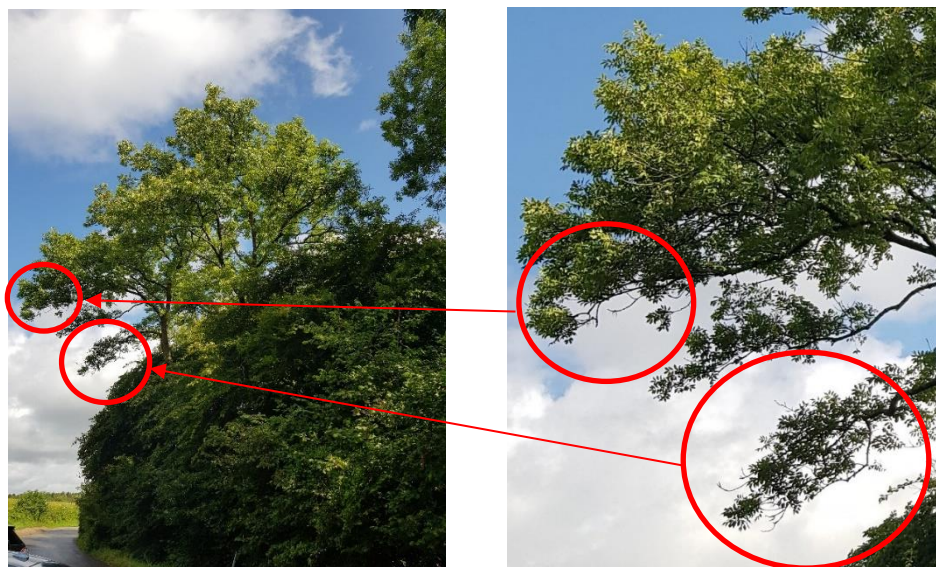
**Stage 1** – This is onset ADD, where bare twigs are present yet the remaining crown appears healthy with no other symptoms yet visible. Approximately 10% of the crown is affected.

**Plate 1: Stage 1 ADD showing bare twigs with no reaction growth present. Often localised with remaining crown healthy.**

**These trees can be generally be monitored and reassessed in 12 months time.**

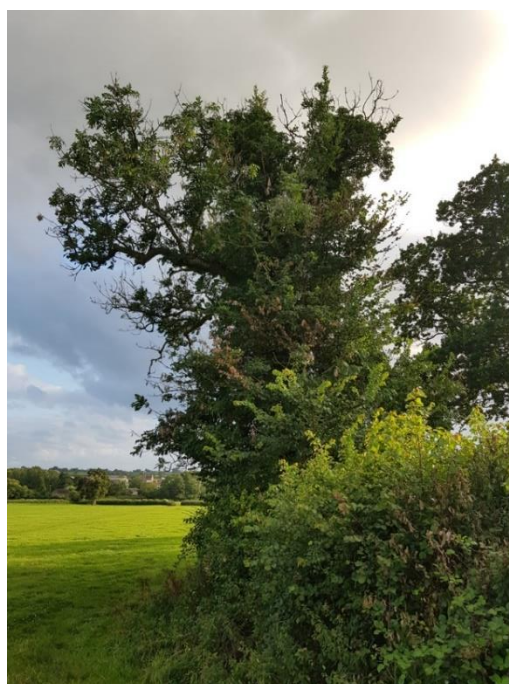
**Stage 2** – The dieback becomes more pronounced and epicormic growth begins to appear below the deadwood on the affected branch. Approximately anything up to 50% of the crown is affected.

**Plate 2: Stage 2 ADD – epicormic growth below areas of dieback**

**Where the target is considered high, tree surgery works should be undertaken in the form of either pruning or removal.**

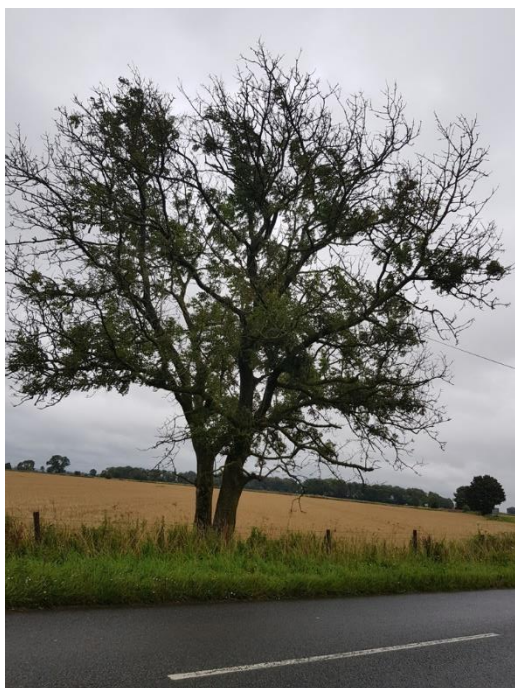
Plate 3: Stage 3 – Significant leaf loss. Epicormic growth is the only crown cover

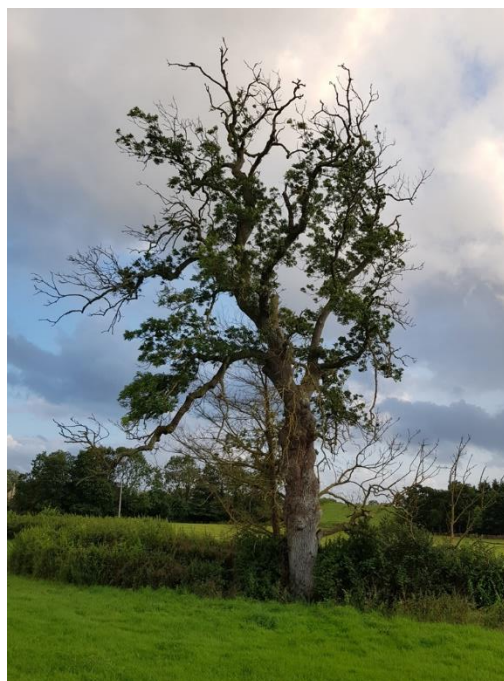
Plate 4: Stage 3 – Tree is too structurally compromised to access with rope and harness.
